Postural Case Study

Subject: Client A

OVERVIEW

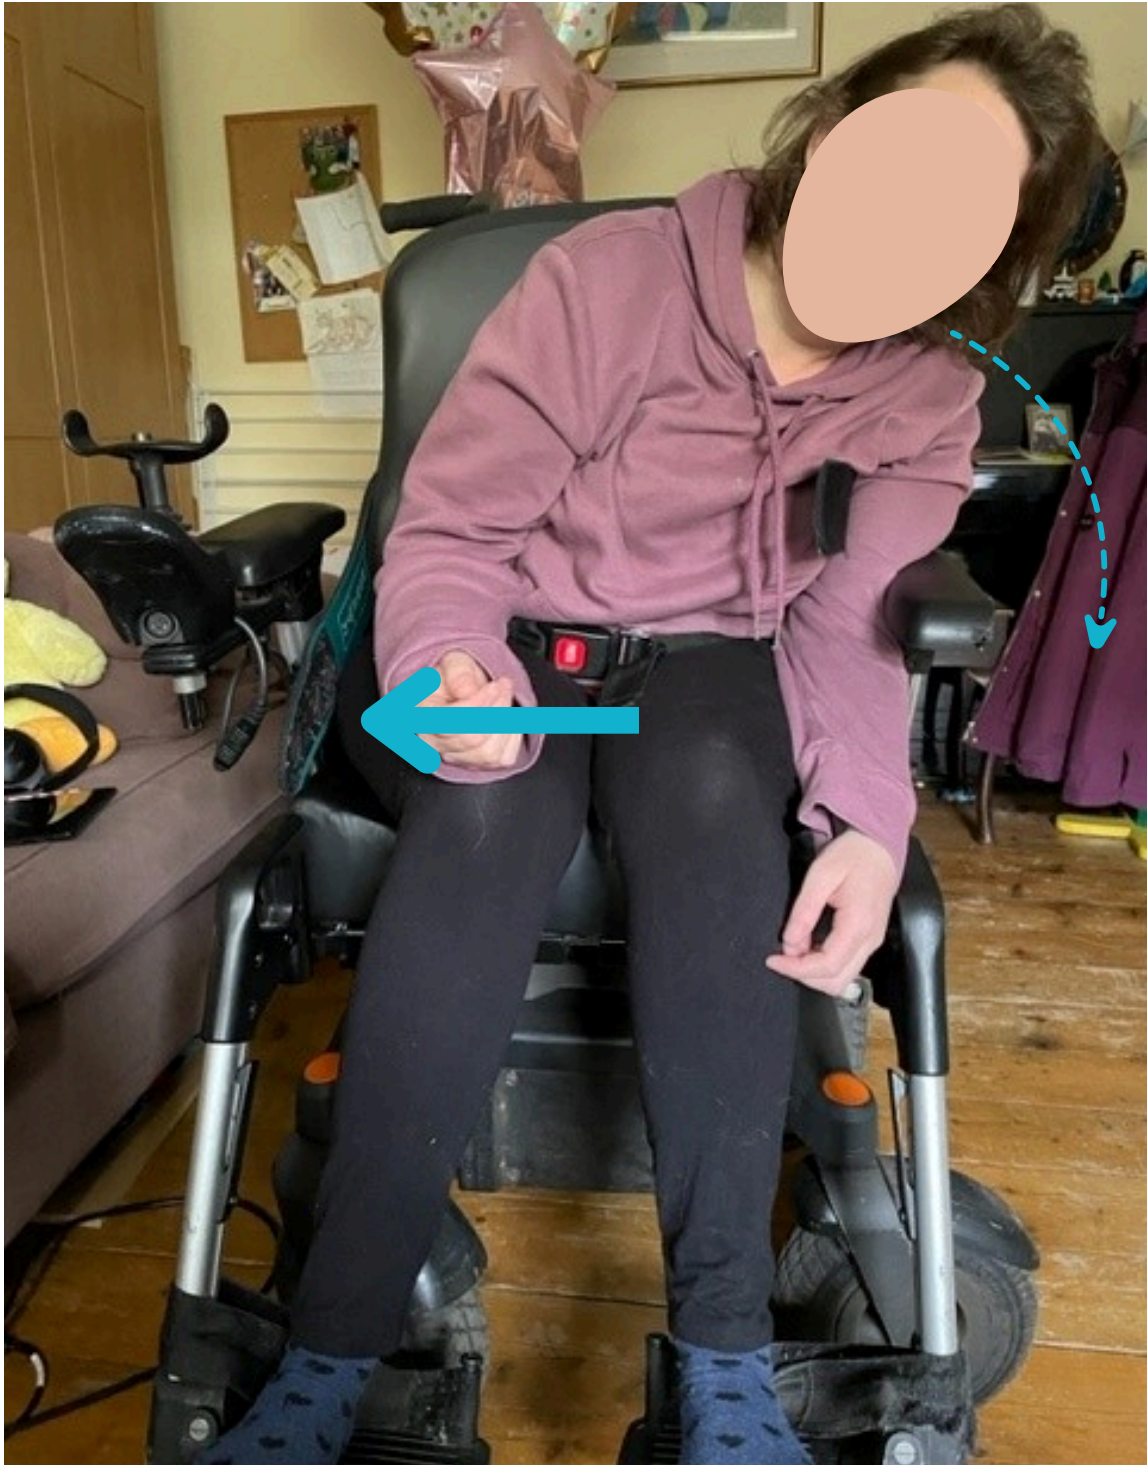
The existing chair's seat width and depth were incorrect. The overly large seat width allowed the client to slide to the right and the long seat depth prevented her from reaching the backrest forcing her to sit posteriorly.

The client reported that after only a short duration in the chair she would collapse forward and fall to the left; this resulted in her hanging either over the armrest or down the inside of the armrest. On some occasions she had even slipped forward off the seat.

The existing backrest with inbuilt lateral support was unable to hold her as she could not sit into the back and when she inevitably dropped forward she was beyond the reach of the laterals; and therefore these performed no useful postural function.

Pelvis drifts to the right resulting in a heavy lean leading from the head

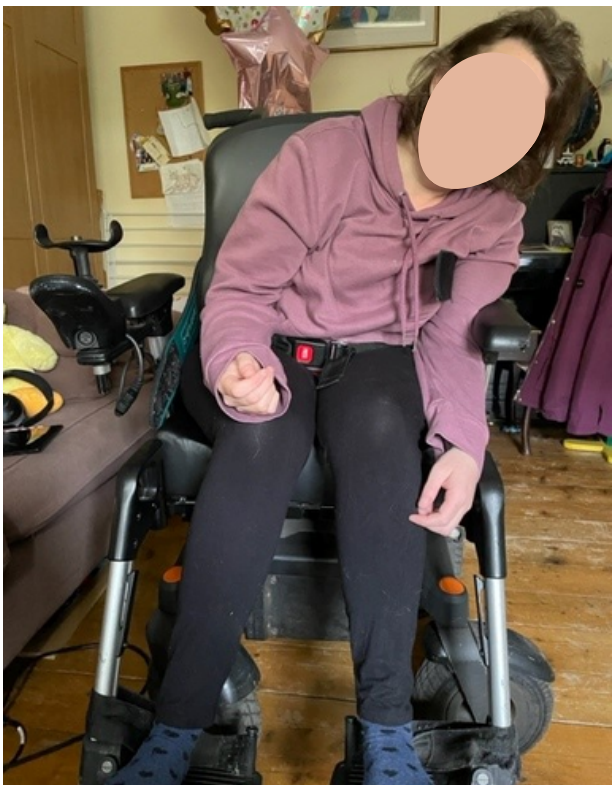
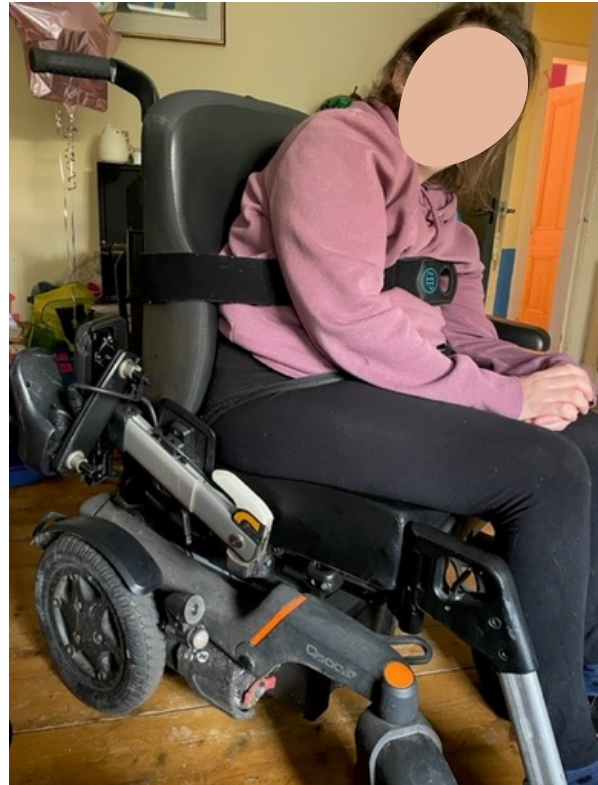
First Postural assessment

Using the plinth allows the team to scrutinize the client's back, pelvic position checking the range of movement in joints to assess what is achievable

The team then get hands on; observing and feeling where the additional support is required. They use their hands to simulate where lateral and wedges are required; gauging feedback and client reactions throughout.

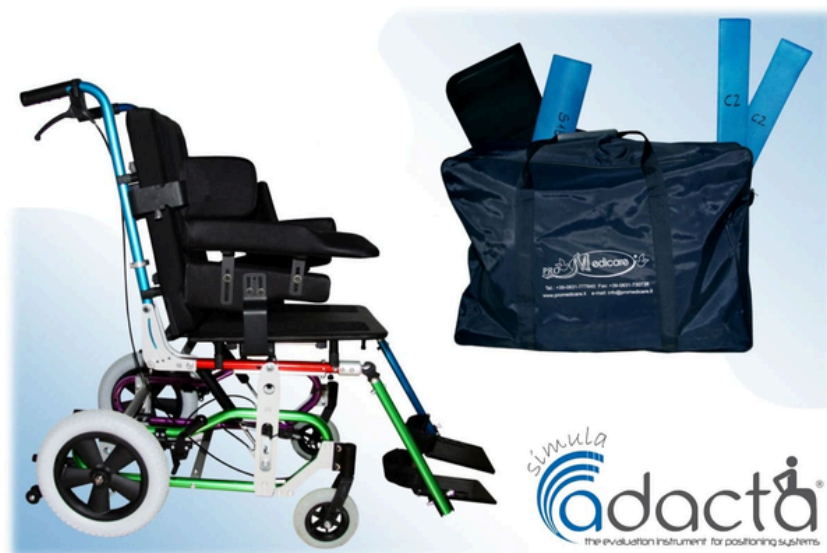
During the initial assessment various cushions and backrests are trialed in numerous combinations to reach the optimum solution for the client's body. Our experience means we understand the scope and limitations of what each product can achieve over the other.

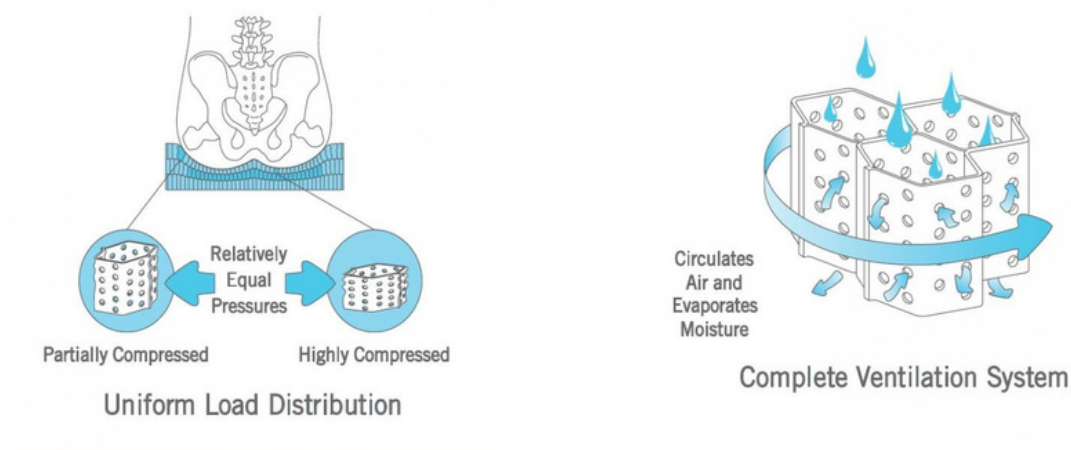
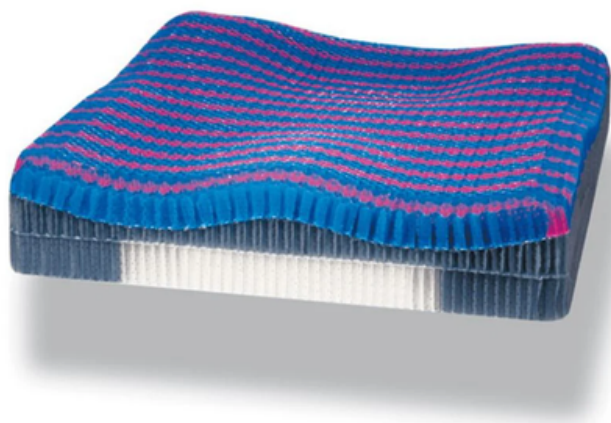
The initial priority is to support the pelvis creating a stable base to build on, which can then be supported

through the use of a postural backrest. To begin with we considered a more supportive cushion, like the Inserto Domino cushion, which held the pelvis perfectly however it was discounted as it was problematic for the client to transfer from. A selection of cushions were tried and the Stimulite range gave pelvic stability, comfort and support for the legs. Stimulite is a honeycomb texture that reacts with body heat to allow the users pelvis to sink deeper into the cushion; immersing bony protuberances whilst supporting surrounding anatomy. Inbuilt shaping guides at the sides and centre front of the cushion guide legs into a midline posture. The Stimulite range can be customised for changing physical and functional needs.

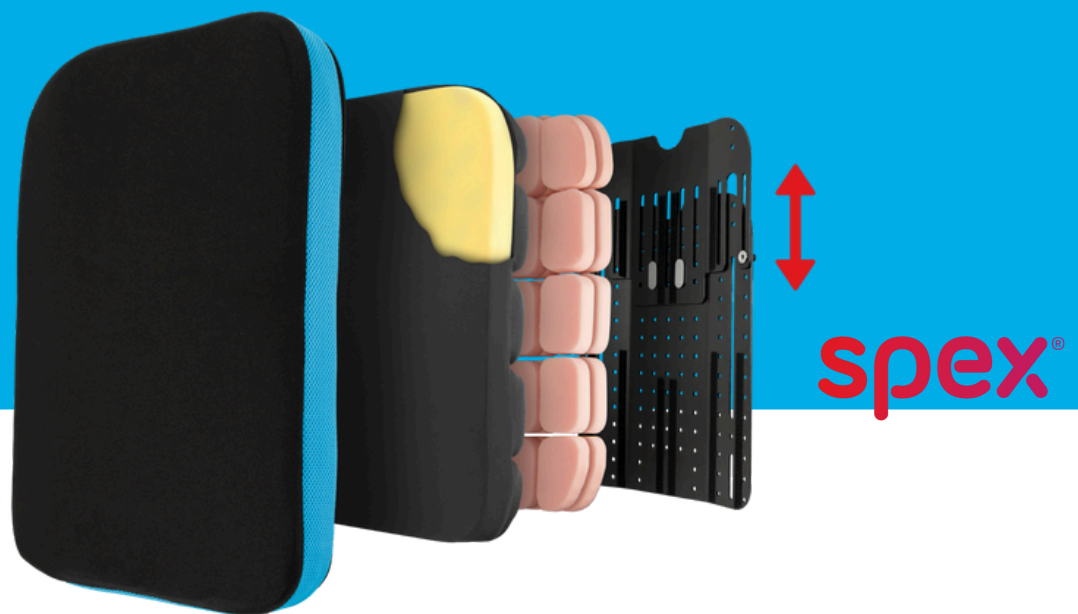
We identified that 'Client A' would benefit from a 'Spex' backrest. This backrest can be built to provide additional support where the user requires, in this case additional lumbar support on the left side of the trunk was required. This back can be fitted with laterals that can be swung in and out by the client. For a Spex back to be installed the existing wheelchair backrest frame had to be changed to canes to accept the Spex clamp fitting.

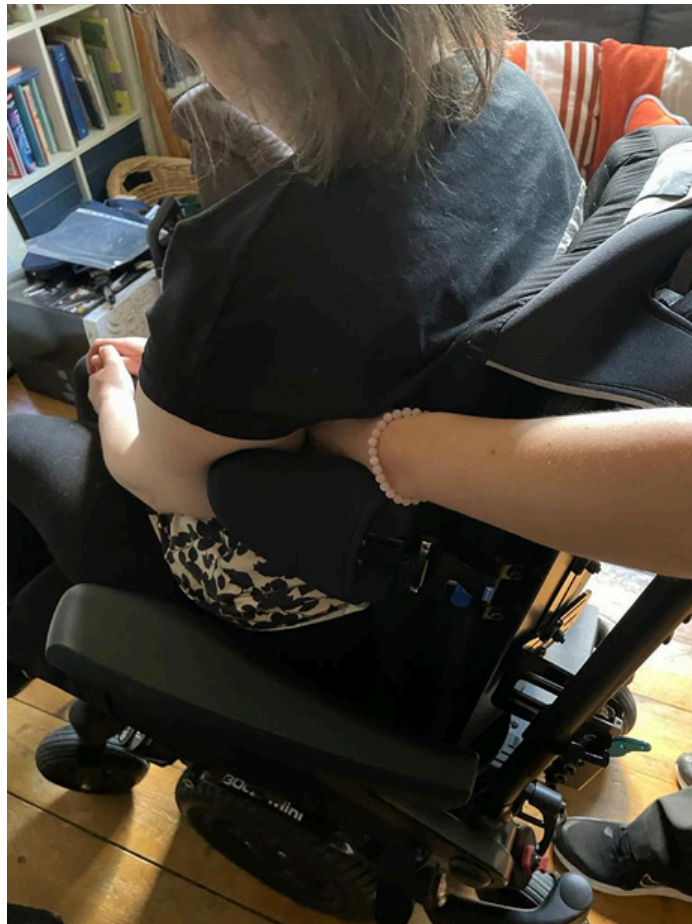
Follow up postural assessment

Laterals were required to provide support for the trunk, ensuring the client is positioned in midline, giving stability to allow them to function during the day. The laterals needed to be sited close against the body, providing a block on the weaker side and support on the upper left. The laterals had to swing in and out so that the client can transfer independently. Experimentation with a range of supports in the backrest allowed full lateral support in the back cushion on the left. Added support just above the lumbar on the right immediately brought the client to midline and gave her the ability to function confidently within the chair.

A pelvic positioning belt was recommended to ensure that the client maintained good pelvic contact in the well of the cushion and to discourage them from adopting the posterior pelvic position that they had to adopt over the past few years.

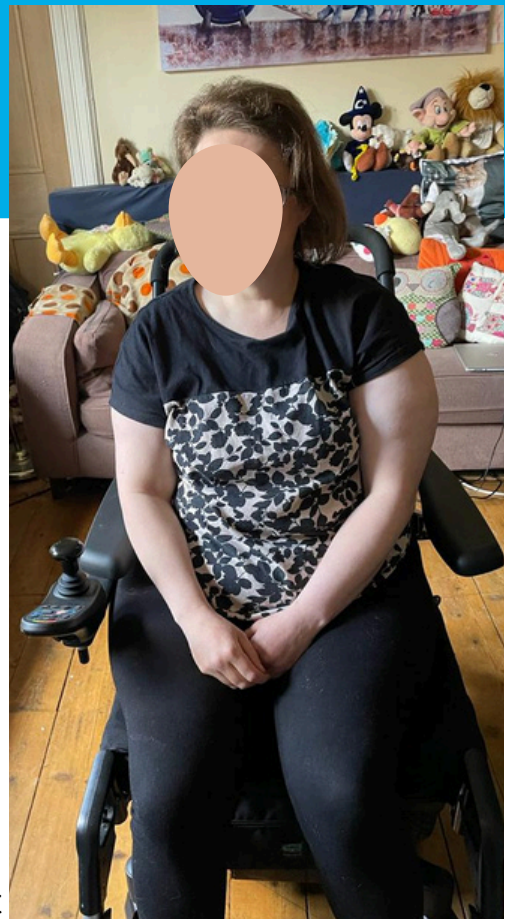
Follow up postural assessment

From the first postural assessment to the follow up seating assessment there is a marked transformation in her posture, this is before adding a postural pelvic belt and before changing the legrests

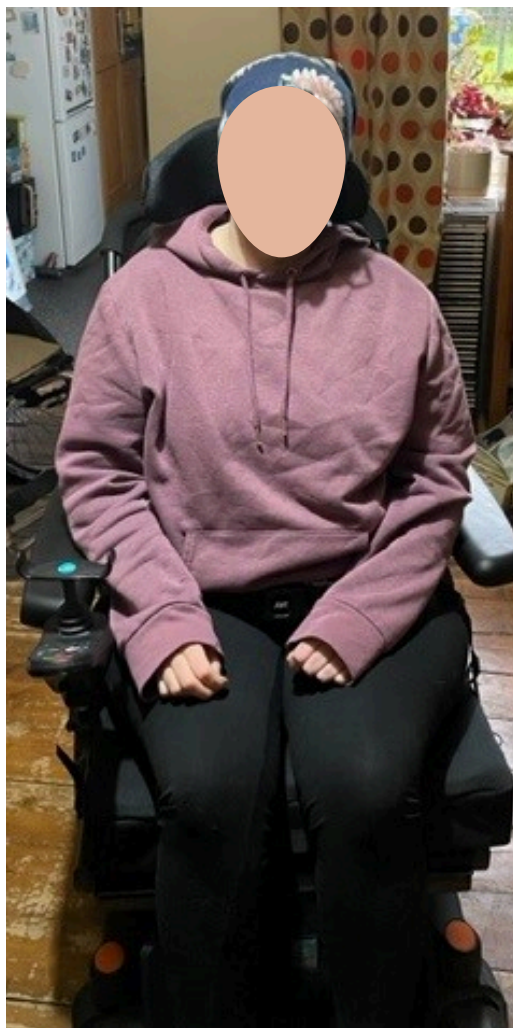
At handover

The difference to the client's posture is incredible, she can now maintain a central position within the chair and is no longer falling forward. She does not require a neoprene strap to hold her up.

Once the Spex backrest is installed we construct the backrest around the client, building in support where she required until we have full contact right down her back, then the laterals are fitted to 'Client A'.
